Evaluation of holographic subsurface radar for NDE of space shuttle thermal protection tiles

Experiments have been carried out to evaluate holographic subsurface radar (RASCAN) for non-destructive evaluation (NDE) of subnominal bond conditions between the Space Shuttle Thermal Protection System tiles and the aluminum substrate. Initial results have shown detection of small voids and spots of moisture between Space Shuttle thermal protection tiles and underlying aluminum substrate. The characteristic feature of this device is the ability to obtain one-sided radar soundings/images with high sensitivity (detecting of wire of 20 micron and less in diameter), and high resolution (2 cm lateral resolution) in the frequency band of 3.6-4.0 GHz. JPL's advanced high-speed image processing and pattern recognition algorithms can be used to process the data generated by the holographic radar and automatically detect and measure the defects. Combining JPL's technologies with the briefcase size, portable RASCAN system will produce a simple and fully automated scanner capable of inspecting dielectric heat shielding materials or other spacecraft structures for cracks, voids, inclusions, delaminati

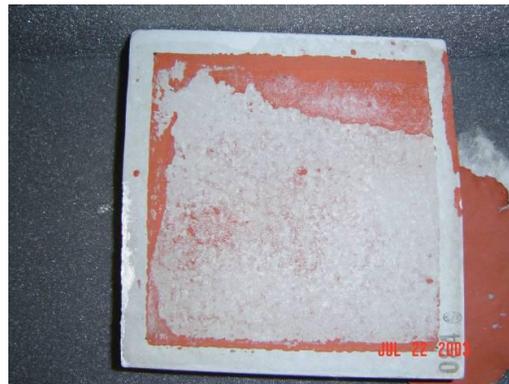
Figure 4: Tile Subnominal Bond Condition

The only way to evaluate the tiles was to remove them nondestructively, so they could be reused, by skiving through the SIP from an adjacent tile cavity. The half of the SIP that remains attached to the tile is typically removed by cutting through the SIP/Tile bond line (Refer to Figure 3). During that SIP removal process, technicians noted the SIP and Room Temperature Vulcanizing (RTV) was peeling adhesively from the Inner Mold Line (IML) on the surface of the tile shown in Figure 4. An adhesive peel, is considered a subnominal bond condition, and is referred to as a subnominal SIP/IML adhesive bond. A nominal SIP to tile bond should have a coat of red RTV on the surface of the tile once the SIP is removed as shown in Figure 5.

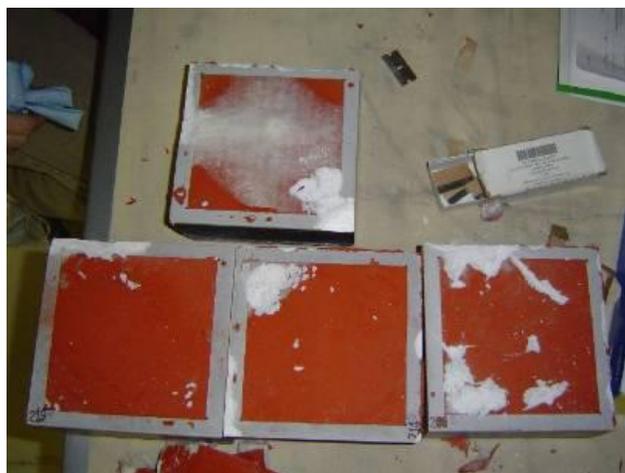
Figure 5: Nominal SIP to Tile Bond Condition
